Debris/Ice/TPS Assessment And Integrated Photographic Analysis For Shuttle Mission STS-47

November 1992

DEBRIS/ICE/TPS ASSESSMENT
AND
PHOTOGRAPHIC ANALYSIS
OF
SHUTTLE MISSION STS-47

September 12, 1992

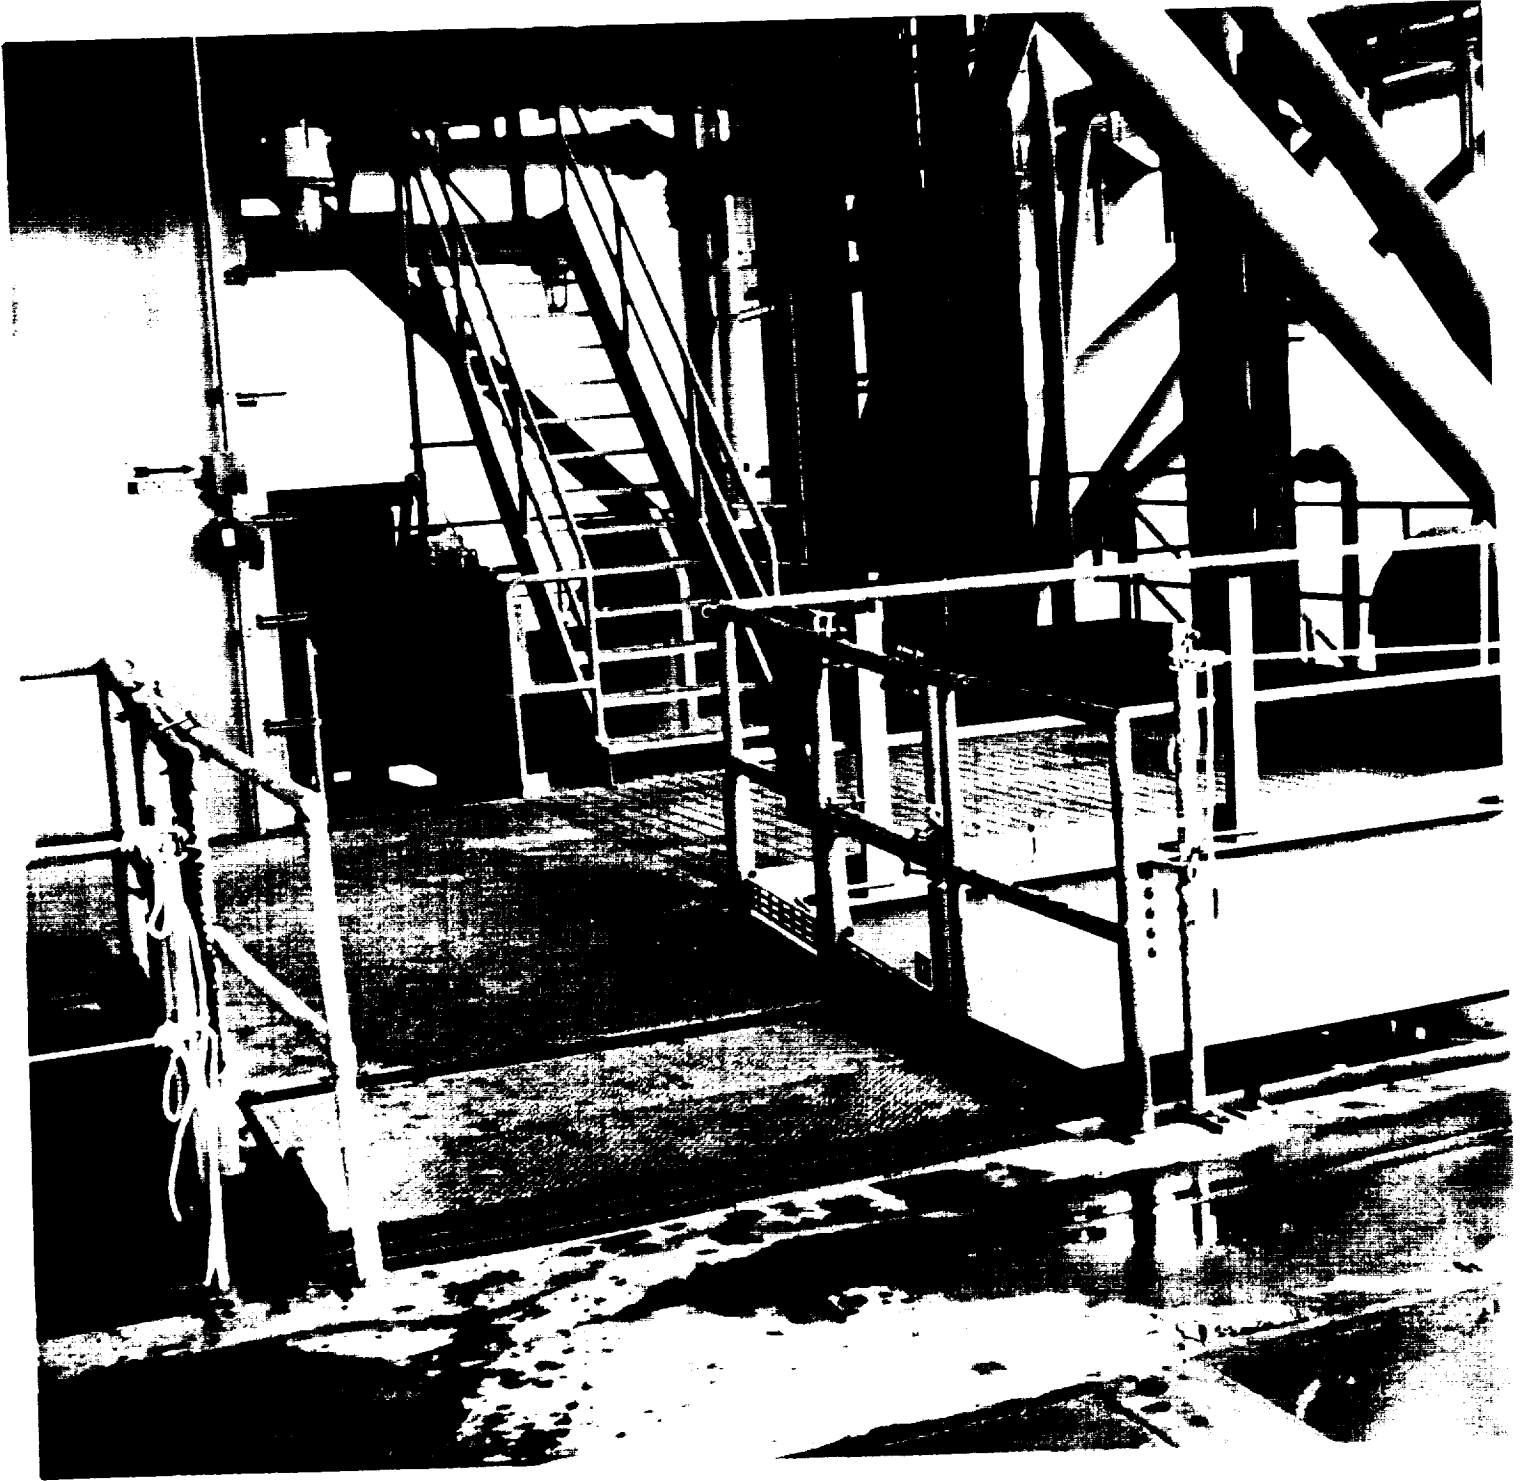
Due to OSHA/safety concerns, semi-permanent handrails were installed at the FSS 95 foot level-to-MLP deck crossover. The handrails remained in place during launch and did not become a debris issue.

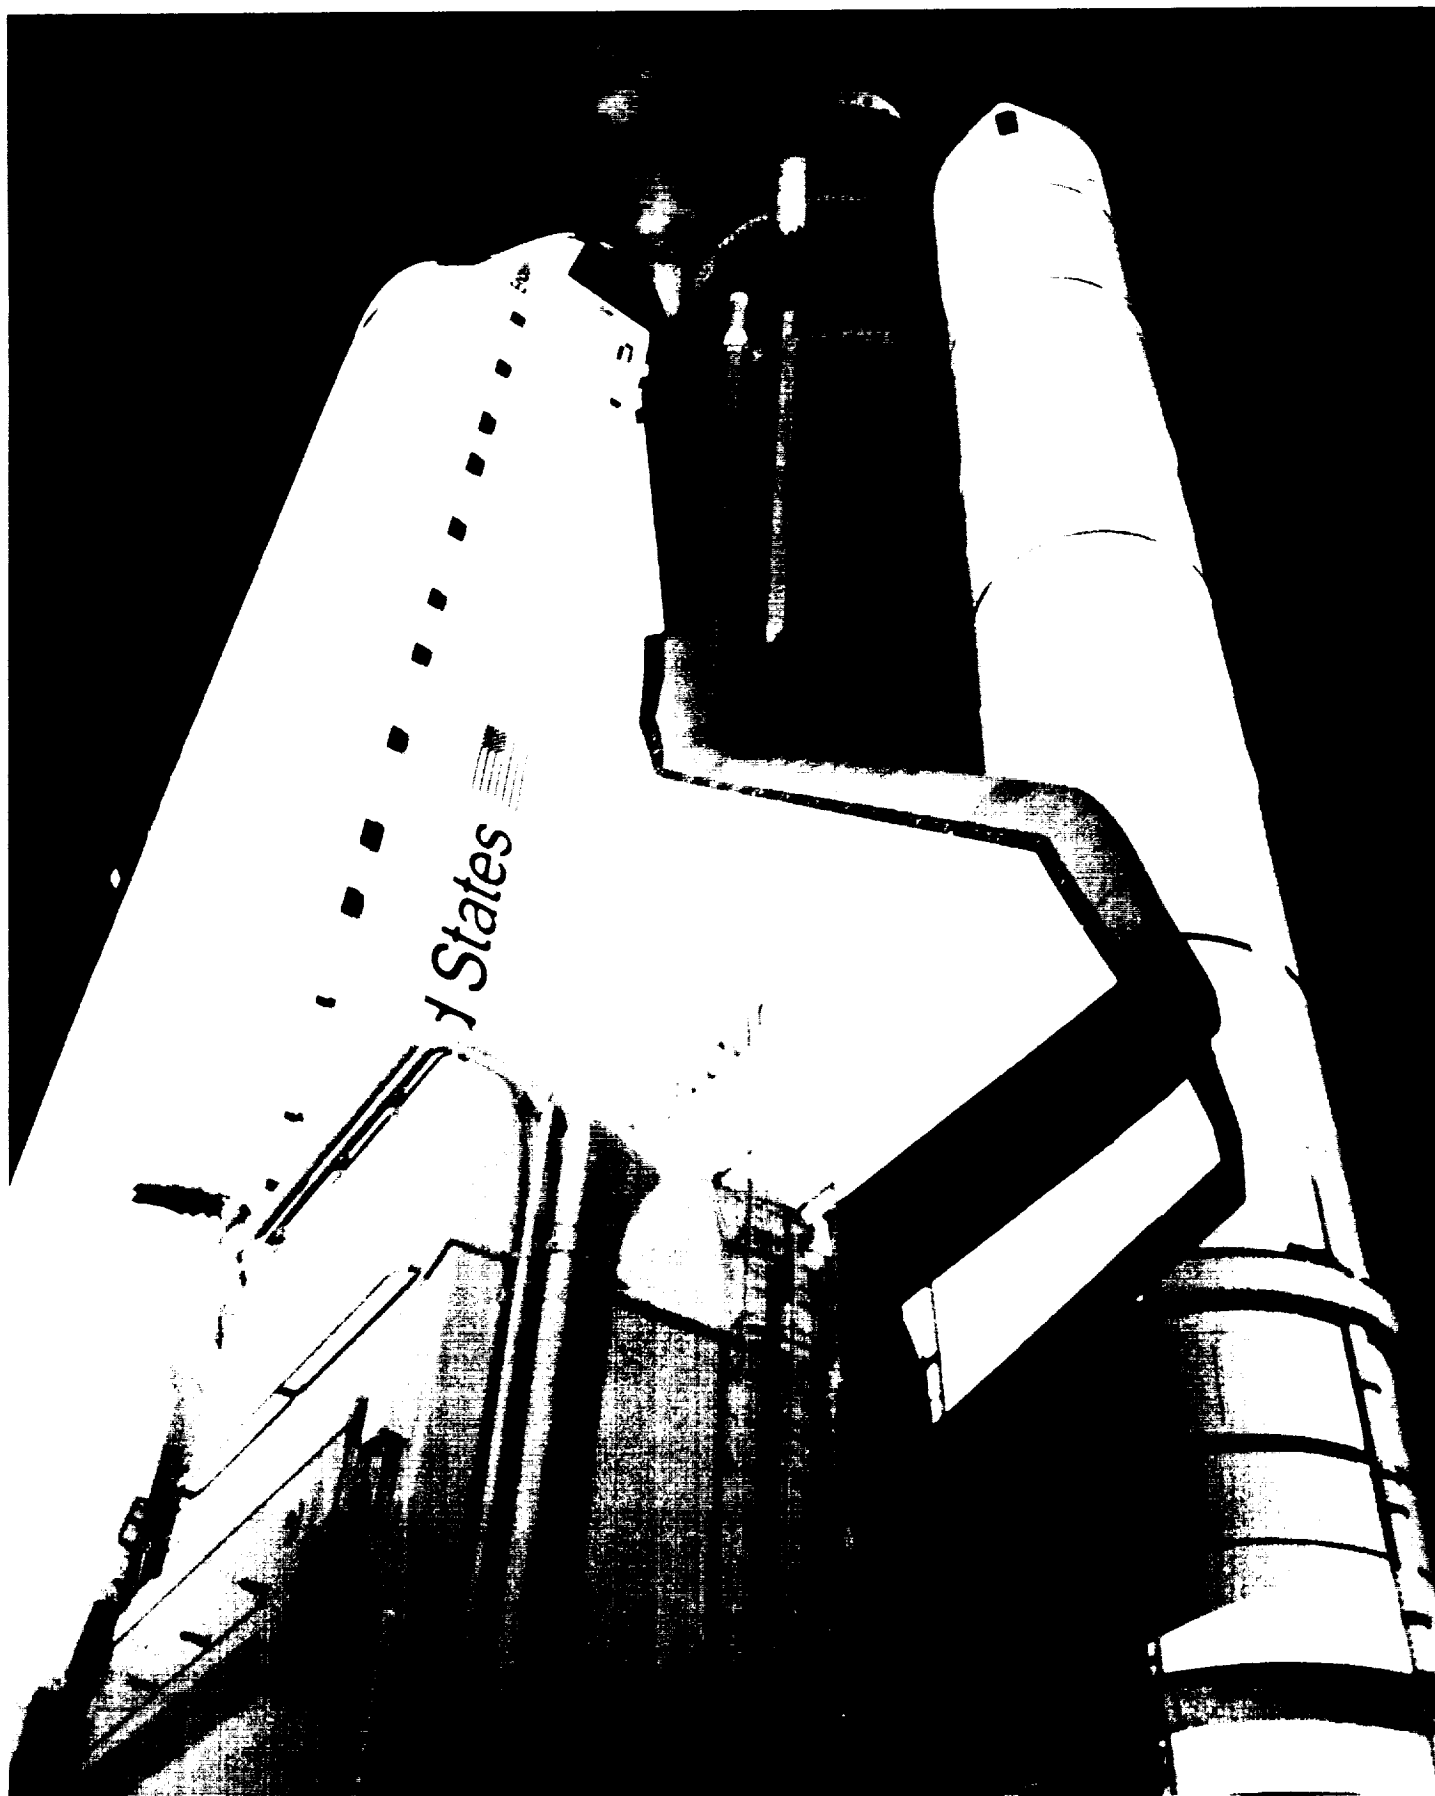
Light condensate, but no ice or frost accumulation, was present
on the ET LO2 and LH2 tank TPS acreage

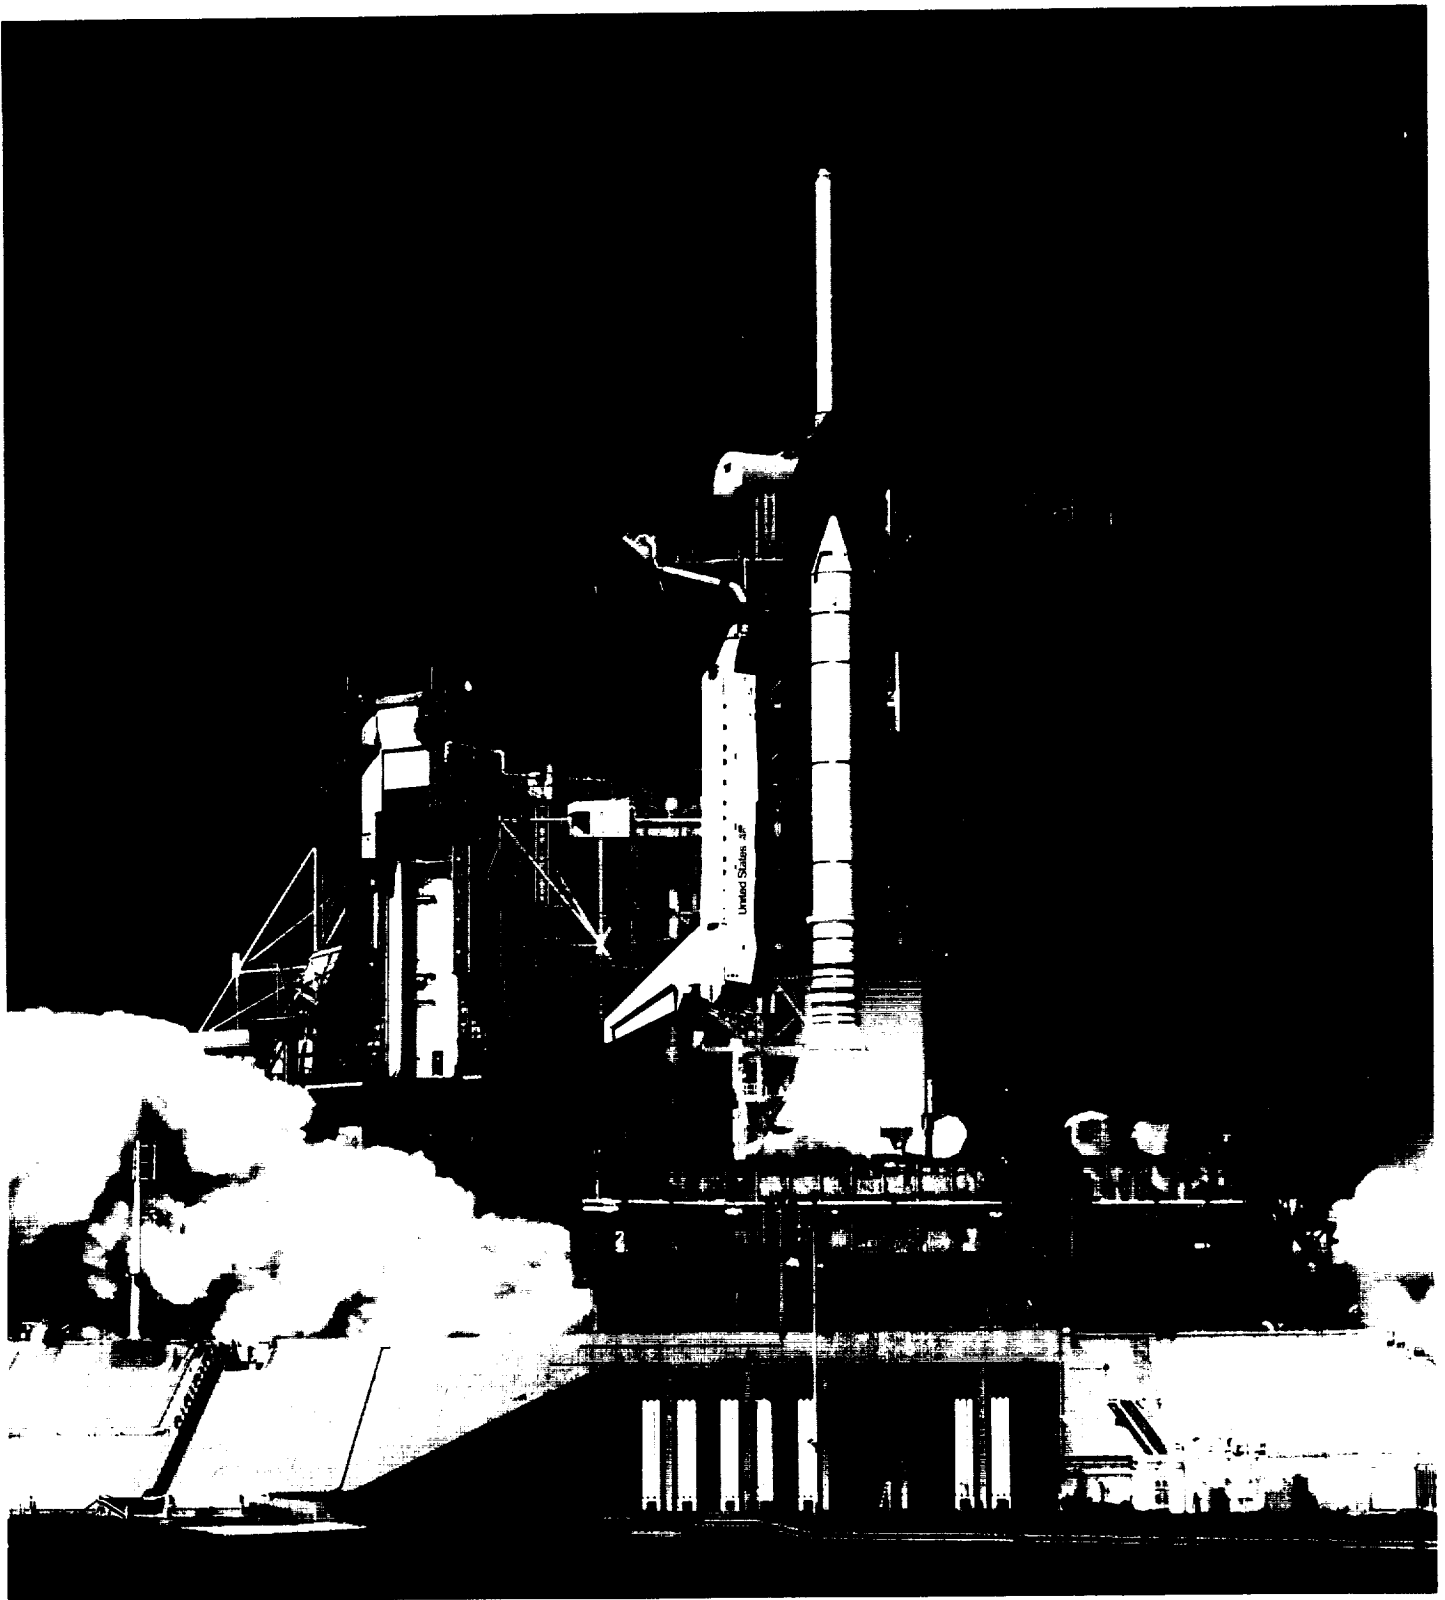
All facility rainbirds operated properly. Light-colored objects over the north end of the MLP were pieces of SRB throat plug material and ice from the cryogenic lines ejected upward by the SRB plume/exhaust.

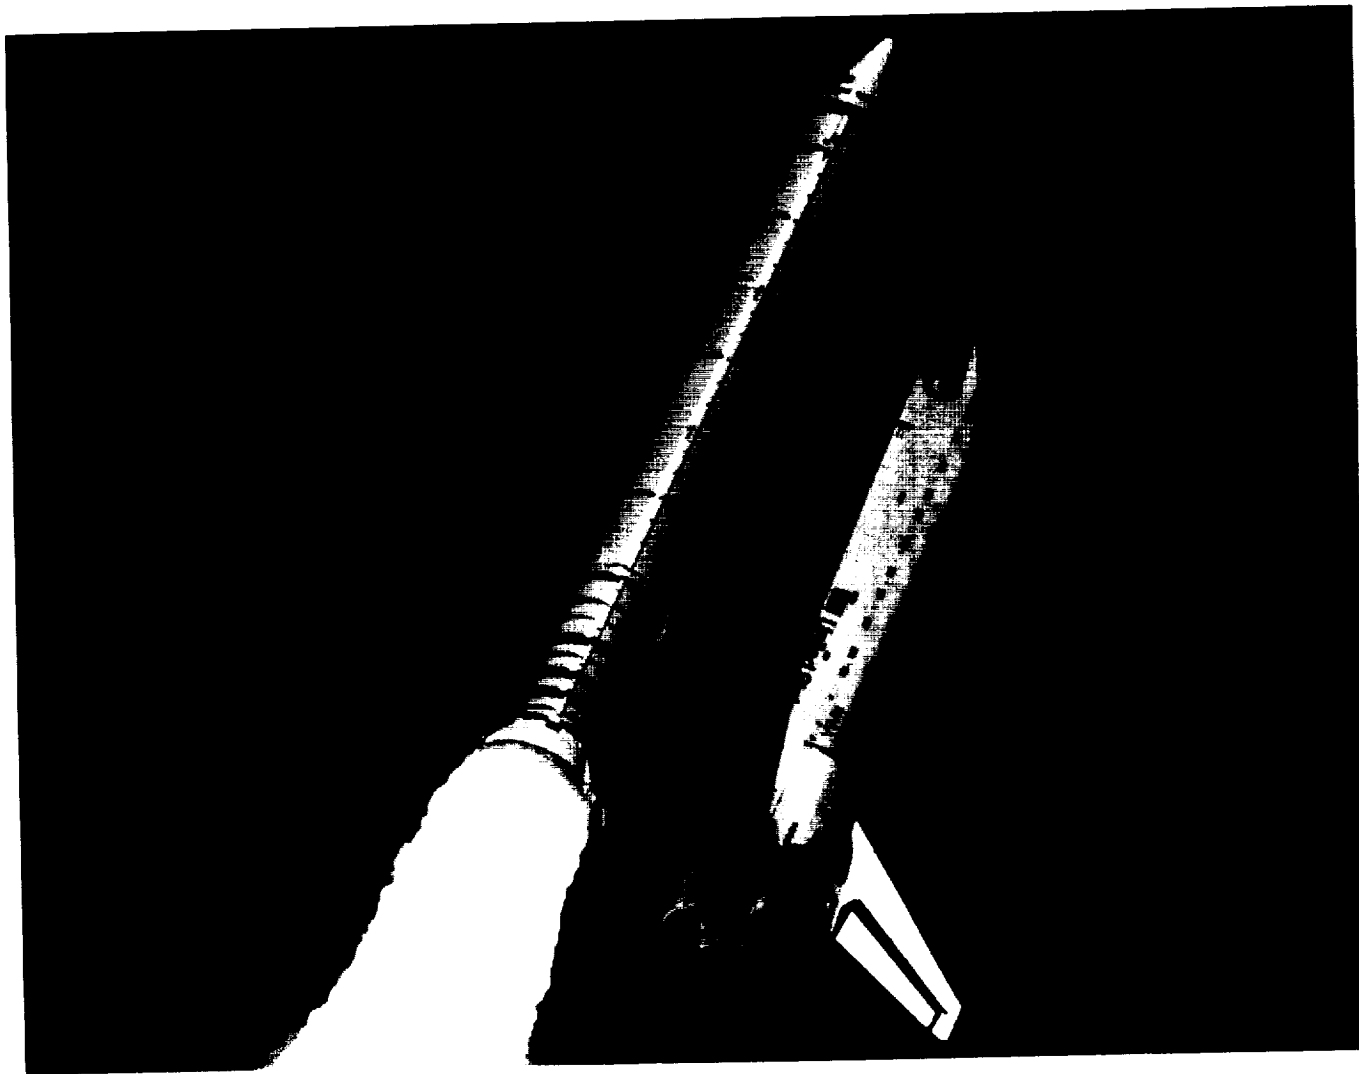
Clusters of particles falling aft of the Orbiter shortly after completion of the roll maneuver were pieces of the LH2 and LO2 ET/ORB umbilical purge barrier (baggie) material. Loss of the purge barrier during flight is a common and expected occurrence

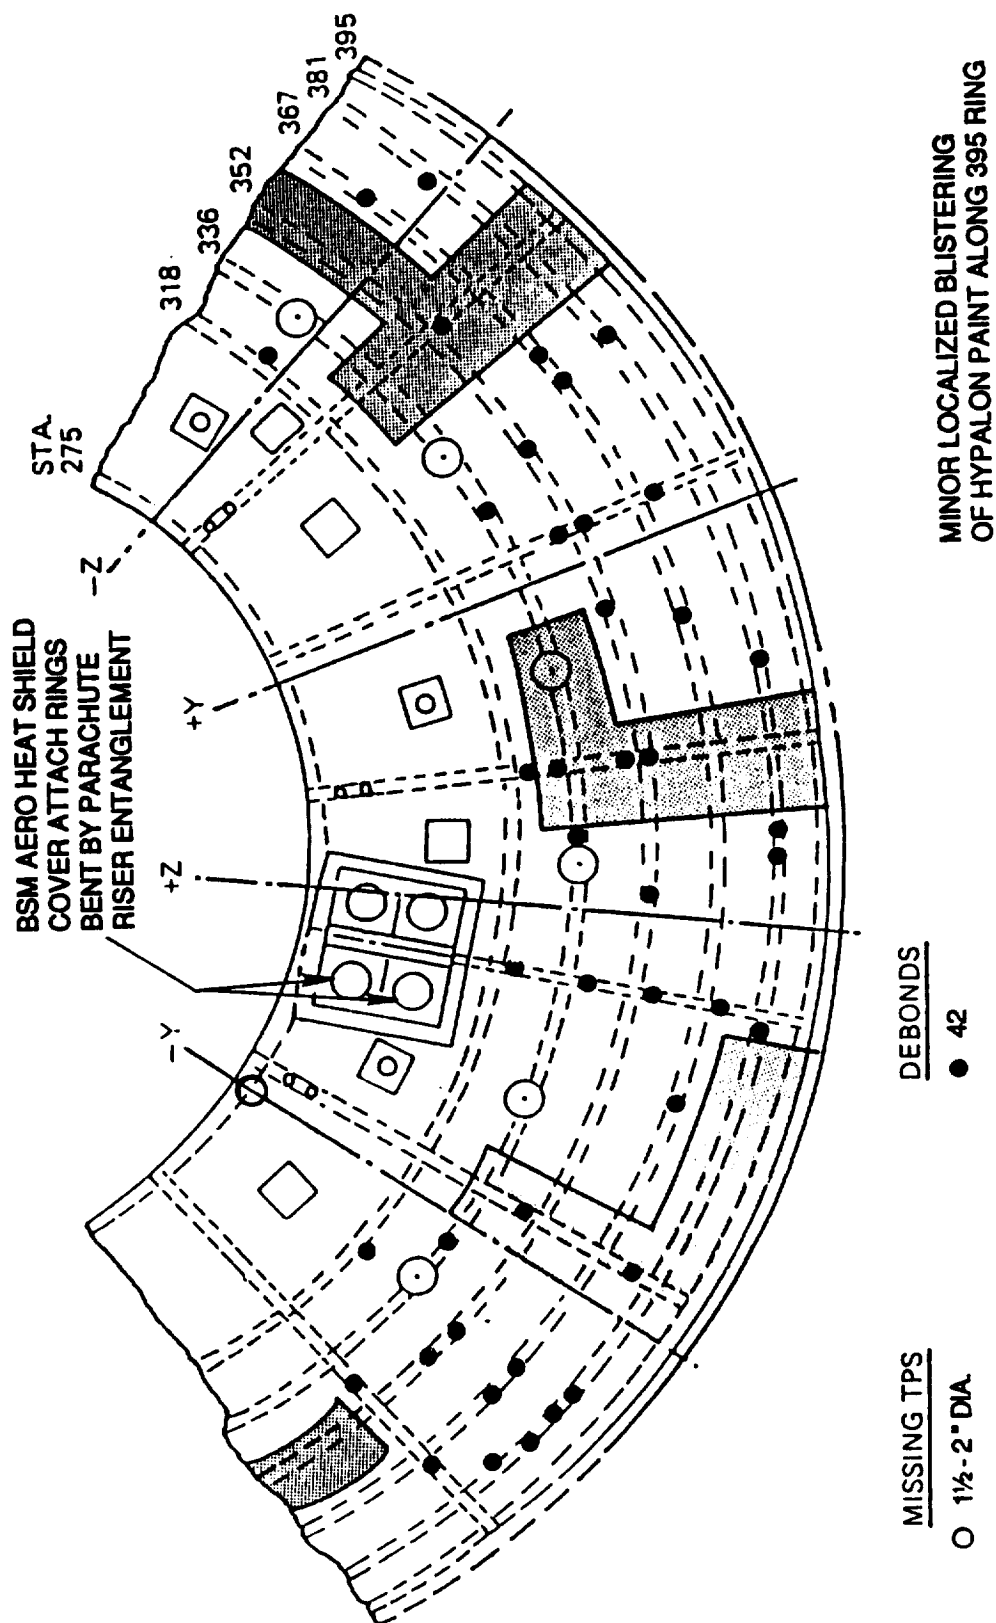
Figure 4. RIGHT SRB FRUSTUM

The RH frustum had 42 MSA-2 debonds over fasteners and one 2-inch diameter area of missing TPS on the -Y axis at the 275 ring frame. Minor localized blistering of the Hypalon paint had occurred predominantly along the 395 ring (Figure 4). All BSM aero heatshield covers were locked in the fully opened position though the left two cover attach rings had been bent by parachute riser entanglement.

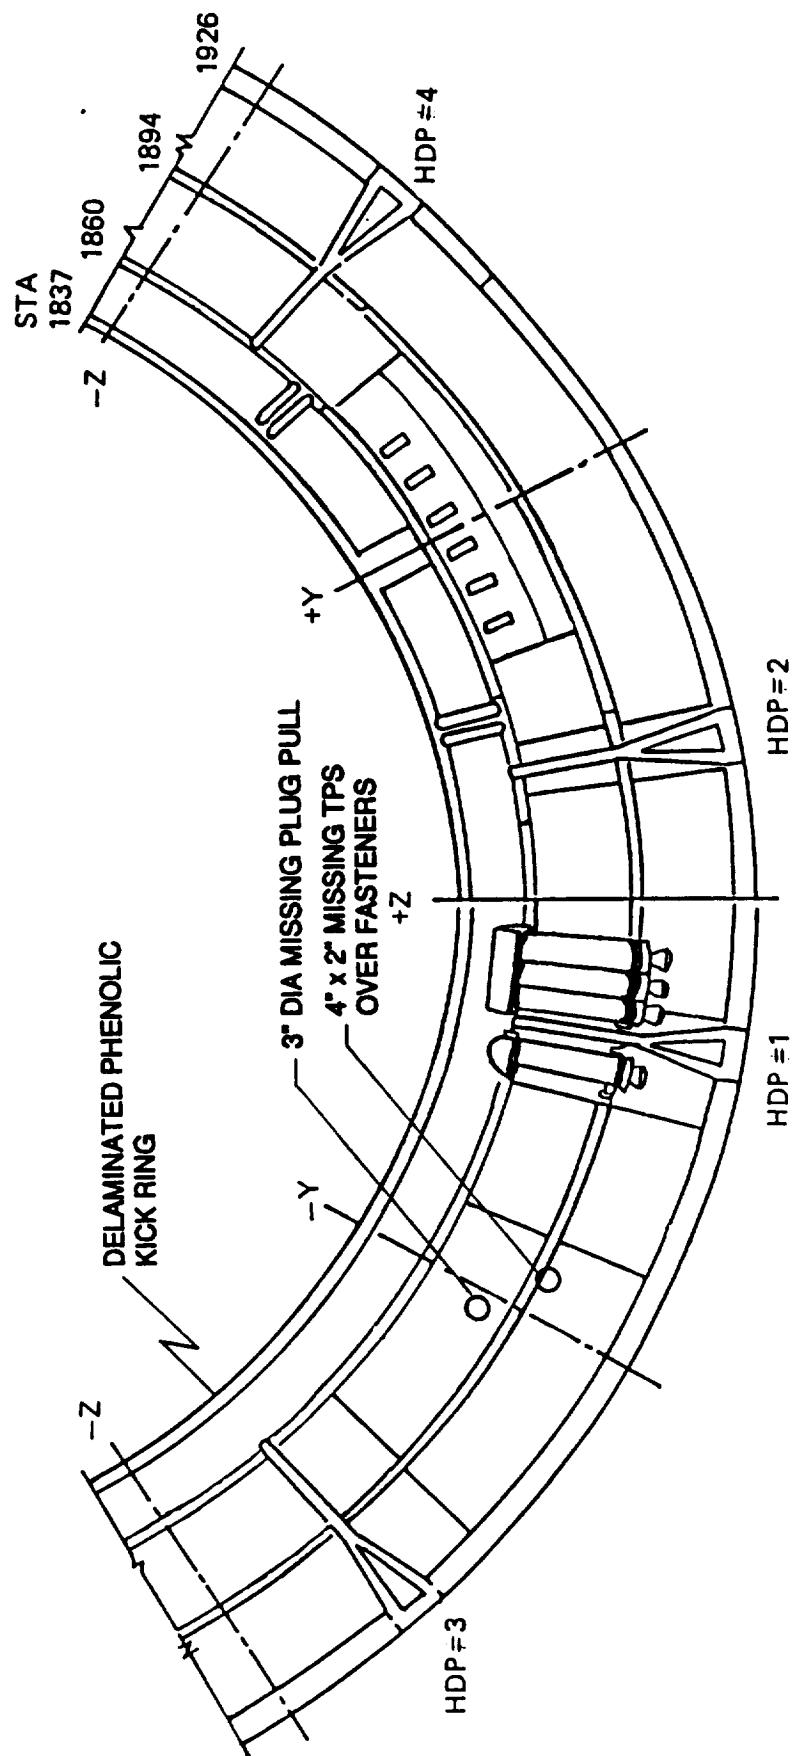
Figure 6. RIGHT SRB AFT SKIRT EXTERIOR TPS

The phenolic material on the kick ring was delaminated. The K5NA closeouts (protective domes) on the kick ring forward and aft fasteners had been eliminated. RTV-133 replaced the K5NA over the forward fasteners. Three divots, measuring 3" in diameter, 4"x2", and 4"x2", had occurred on the aft skirt TPS (Figure 6).

All Debris Containment System (DCS) plungers were seated properly. This was the tenth flight utilizing the optimized link. Pieces of EPON shim were missing from HDP #4 (3-inch diameter) and HDP #3 (2-inch diameter). The material was lost prior to water impact (sooted/charred substrate).

MINOR BLISTERING OF HYPALON PAINT ON SYSTEMS TUNNEL COVER AND ET/SRB ATTACH POINT

ALL DCS PLUNGERS
PROPERLY SEATED

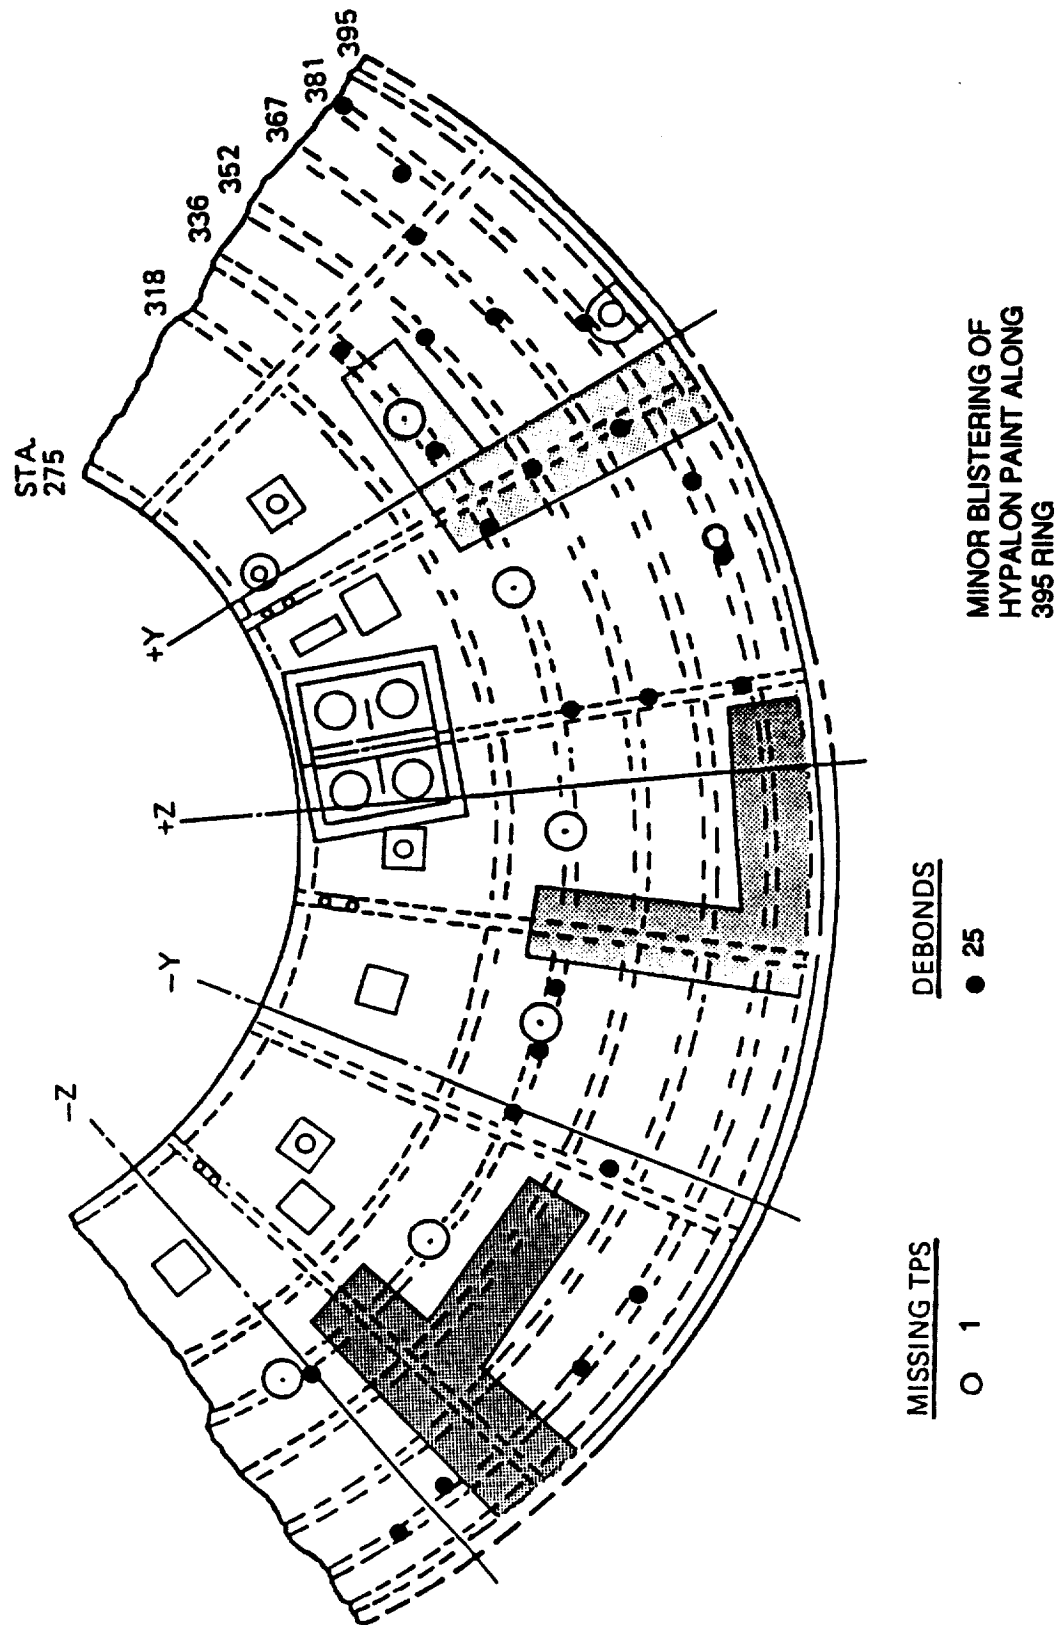
Figure 7. LEFT SRB FRUSTUM

The LH frustum had 25 MSA-2 debonds over fasteners and was missing MSA-2 (1.5-inch diameter) from one location between the +Y and +Z axes on the 381 ring frame (Figure 7). There was minor localized blistering of the Hypalon paint. The BSM aero heatshield covers were locked in the fully opened position.

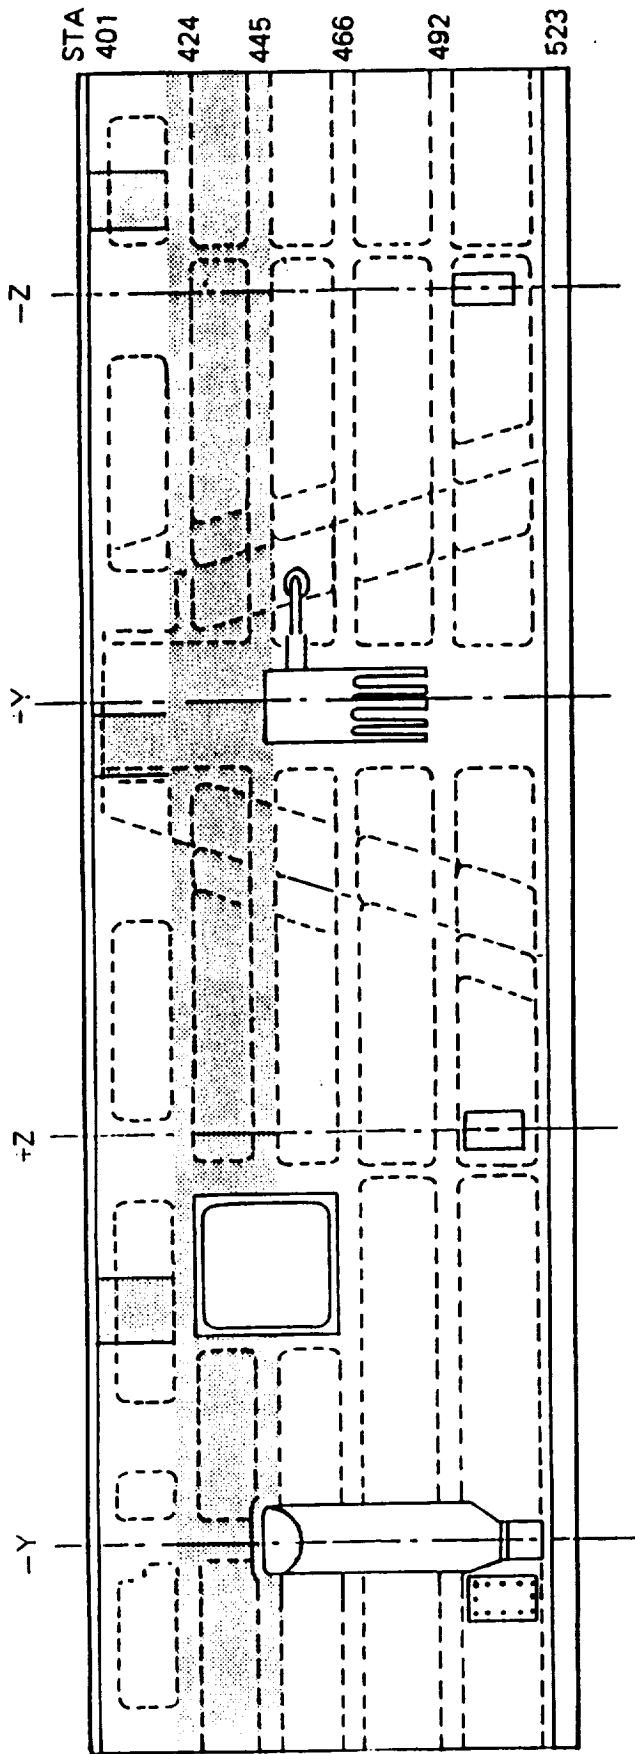
Figure 8. LEFT SRB FWD SKIRT

The LH forward skirt exhibited no debonds or missing TPS. The phenolic plates on both RSS antennae were intact and undamaged (Figure 8). The forward separation bolt and electrical cables appeared to have separated cleanly. No pins were missing from the frustum severance ring. Minor blistering of the Hypalon paint occurred near the ET/SRB attach point and on the systems tunnel cover.

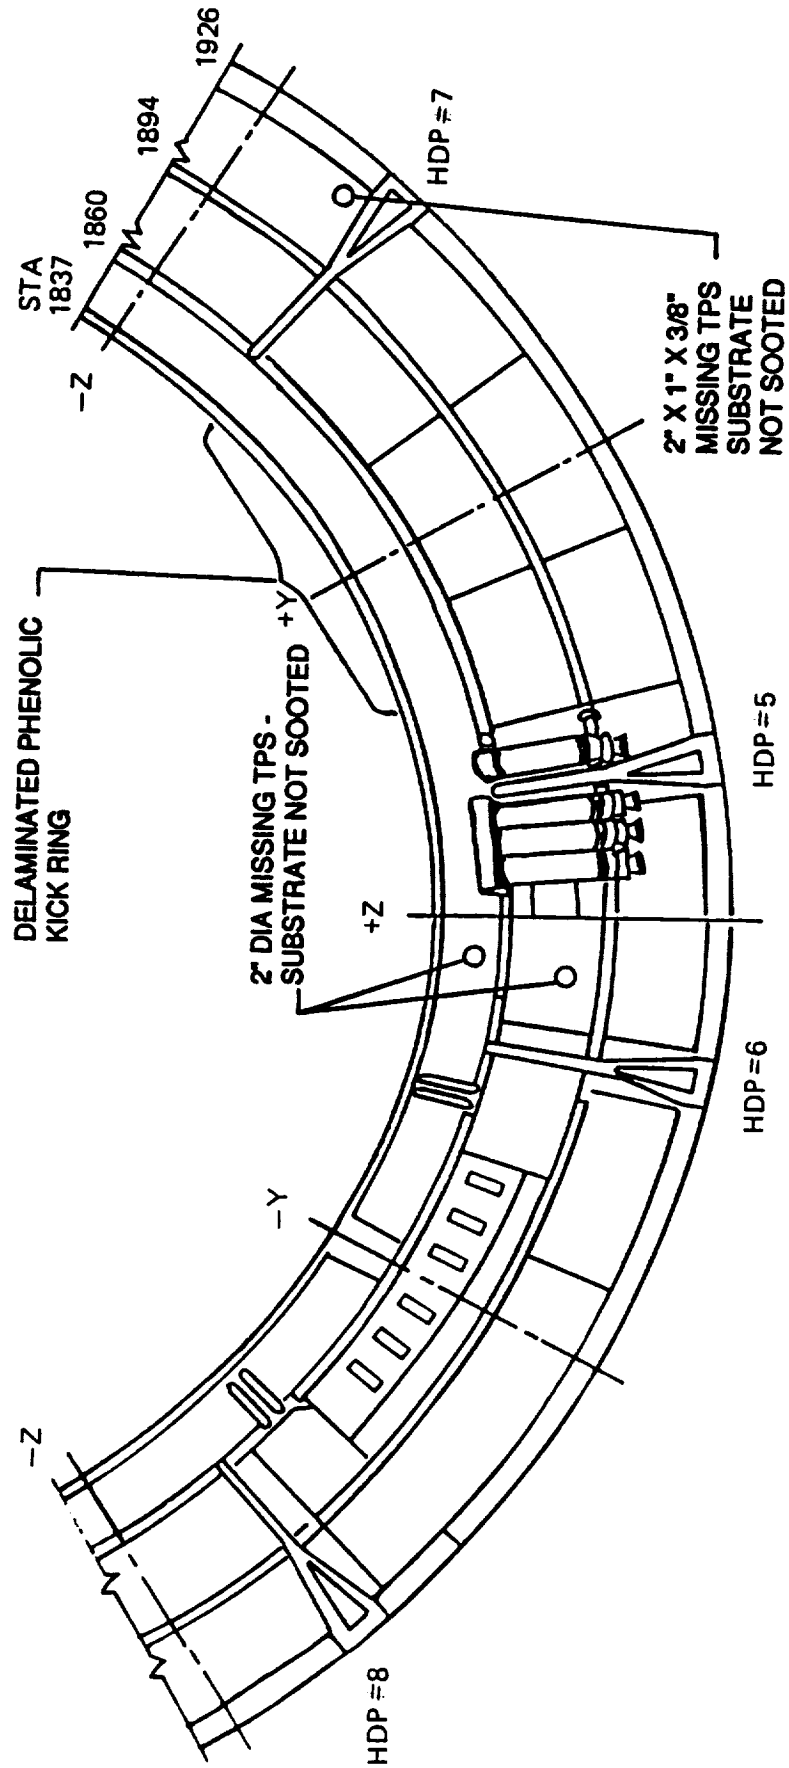
Figure 9. LEFT SRB AFT SKIRT EXTERIOR TPS

The phenolic material on the kick ring was delaminated. The K5NA closeouts (protective domes) on the kick ring forward and aft fasteners had been eliminated. RTV-133 replaced the K5NA over the forward fasteners. Three divots, measuring 2" in diameter (two places near the BSM's) and 2"x1" (one place near HDP #7), occurred on the aft skirt acreage TPS (Figure 9).

All four Debris Containment System (DCS) plungers were properly seated. This was the tenth flight utilizing the optimized link. Pieces of EPON shim material were missing from HDP #7 prior to water impact (sooted/charred substrate).

MINOR BLISTERING OF
HYPALON PAINT ON
SYSTEMS TUNNEL COVER
AND ET/SRB ATTACH FITTING

ALL DCS PLUNGERS
PROPERLY SEATED

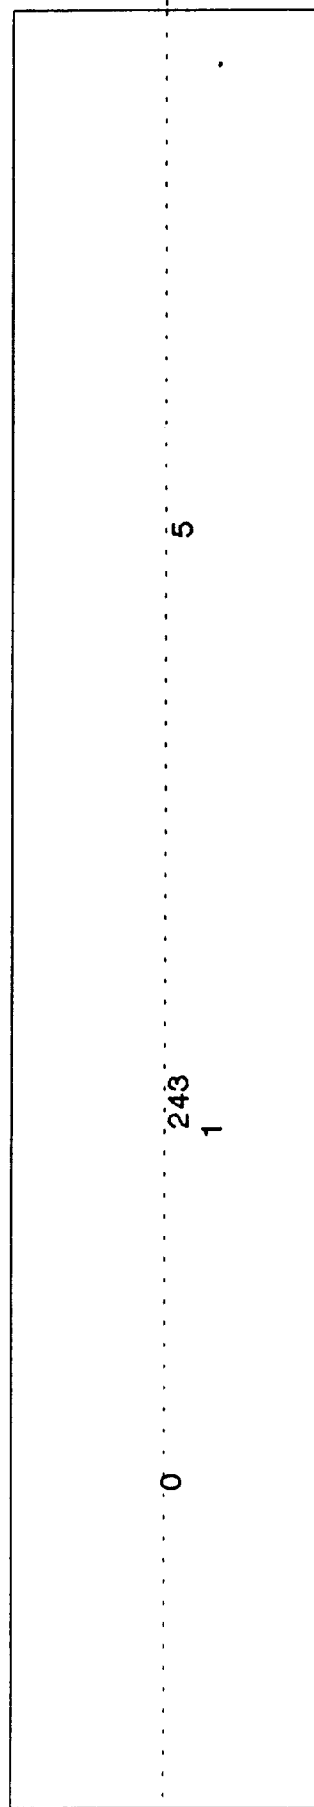
Figure 15.

This flight marked the third use of the Orbiter drag chute. The drag chute appeared to have functioned nominally. However, three tiles on the LH edge of the vertical stabilizer "stinger" suffered significant damage/material loss due to contact with the riser lines during chute deployment. Another tile, on the lower (-Z) RH edge of the drag chute opening, was slightly damaged by separation of the chute compartment door. All drag chute hardware was recovered and showed no signs of abnormal operation (reference Figure 15 for recovery locations).

- 0 (MLG TOUCHDOWN): 2500'
- 1 (MORTAR COVER): 5500', 90' R OF C/L
- 2 (SABOT): 5650', 25' R OF C/L
- 3 (DOOR): 5900', 30' R OF C/L
- 4 (PILOT CHUTE): 5670', 25' R OF C/L
- 5 (MAIN CHUTE): 10300', 30' R OF C/L

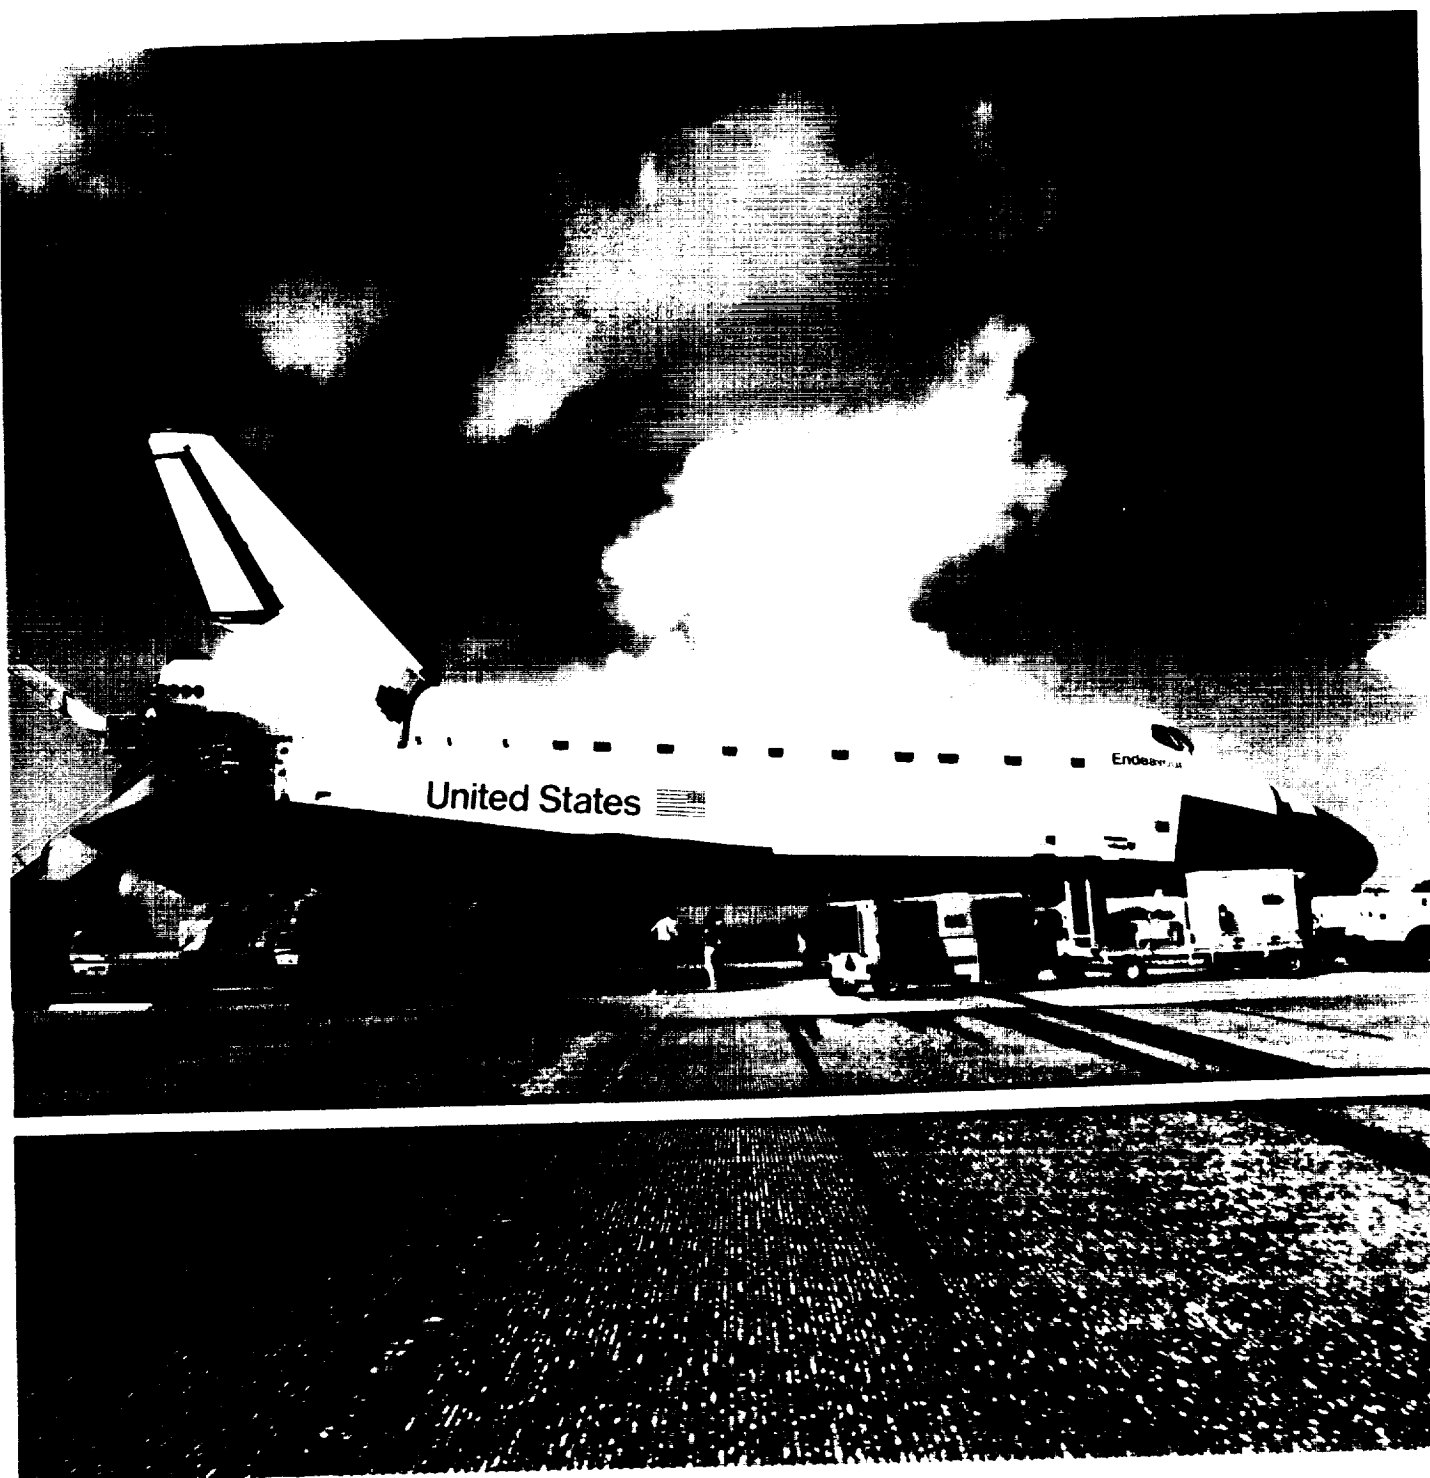
The Orbiter lower surface tiles sustained a total of 47 hits, of which three had a major dimension of 1-inch or greater. These numbers are much less than average.

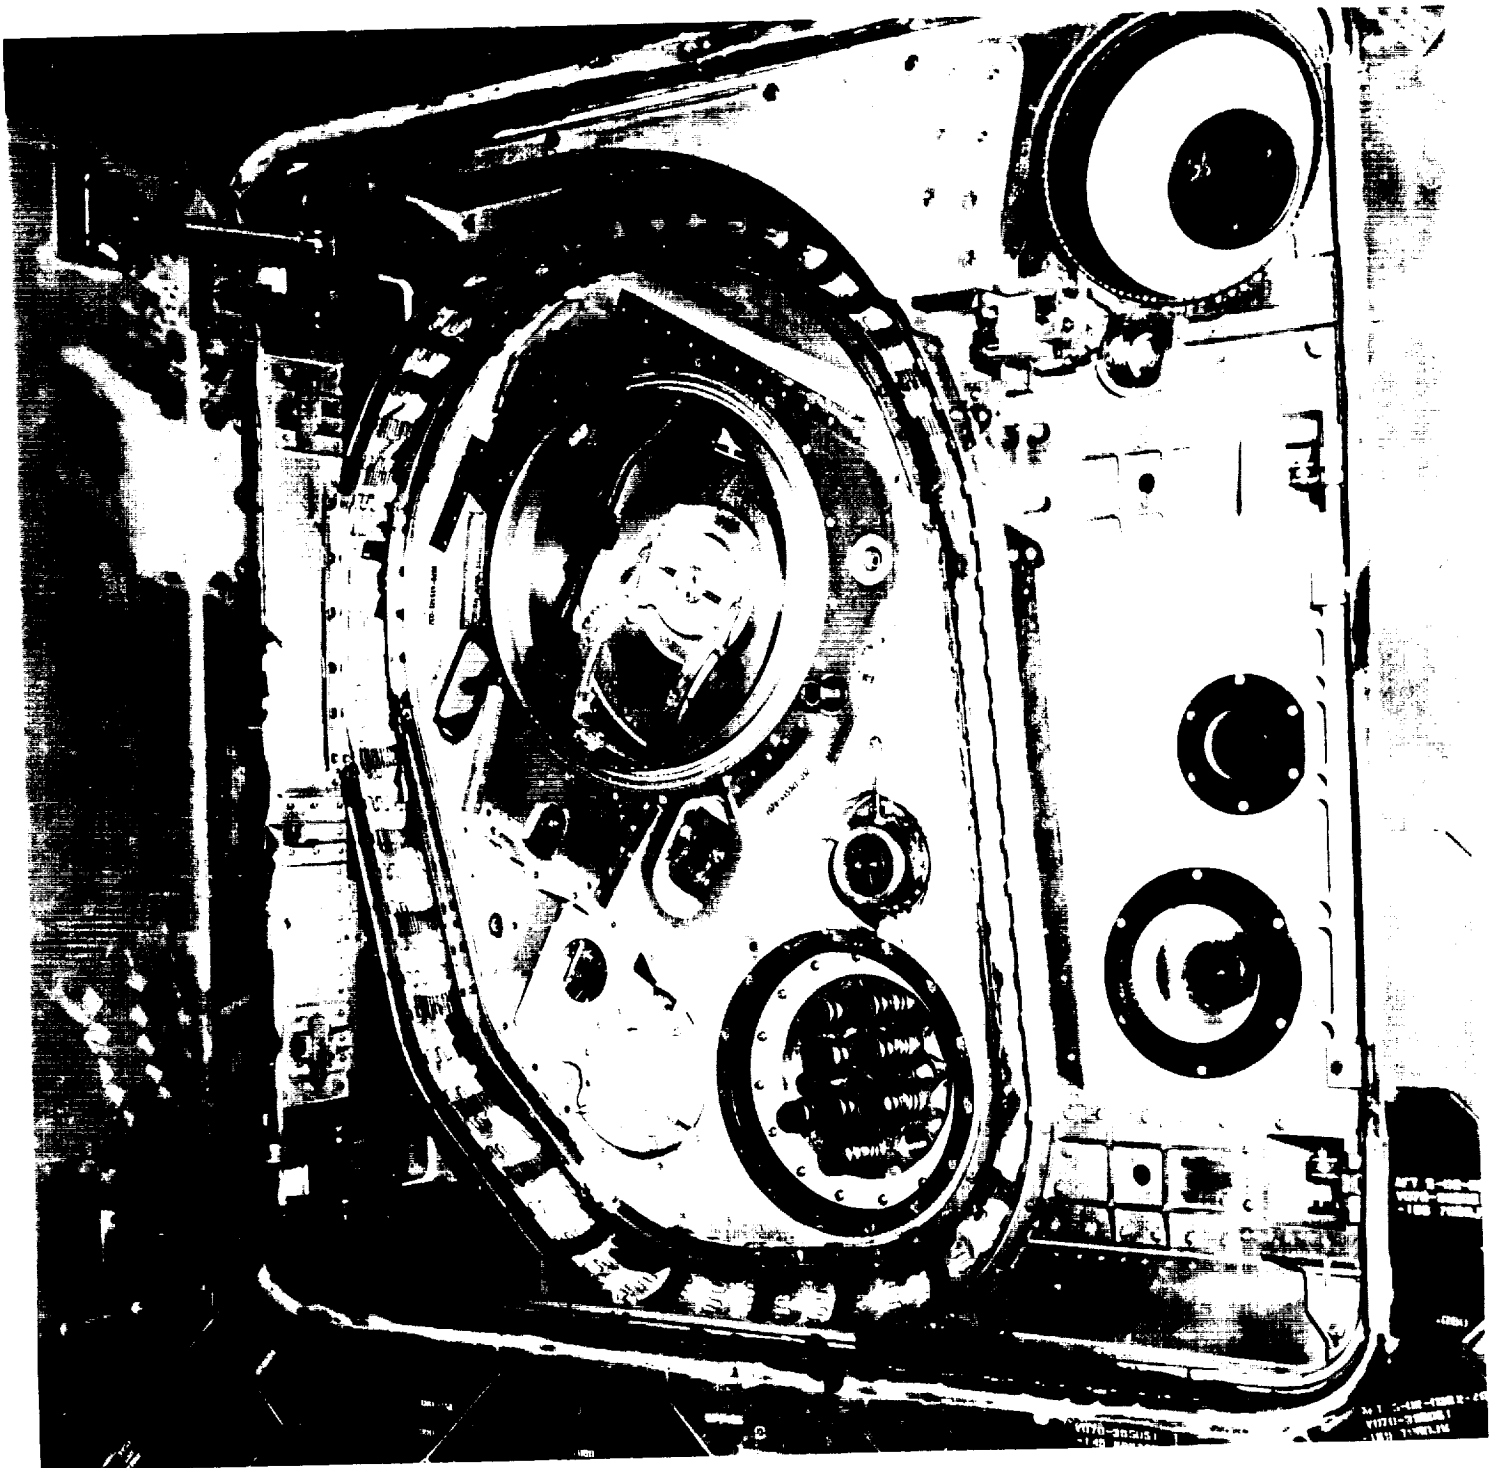
Overall view of the LH2 ET/ORB umbilical. All separation ordnance devices appeared to have functioned properly. No flight hardware was found on the runway below the umbilical when the ET door was opened.
